Conservation of Roman Cement facades.

Trade Academy in Krakow
and other examples.

Jacek Olesiak
Konservator, Remmers,
Krakow, Polen

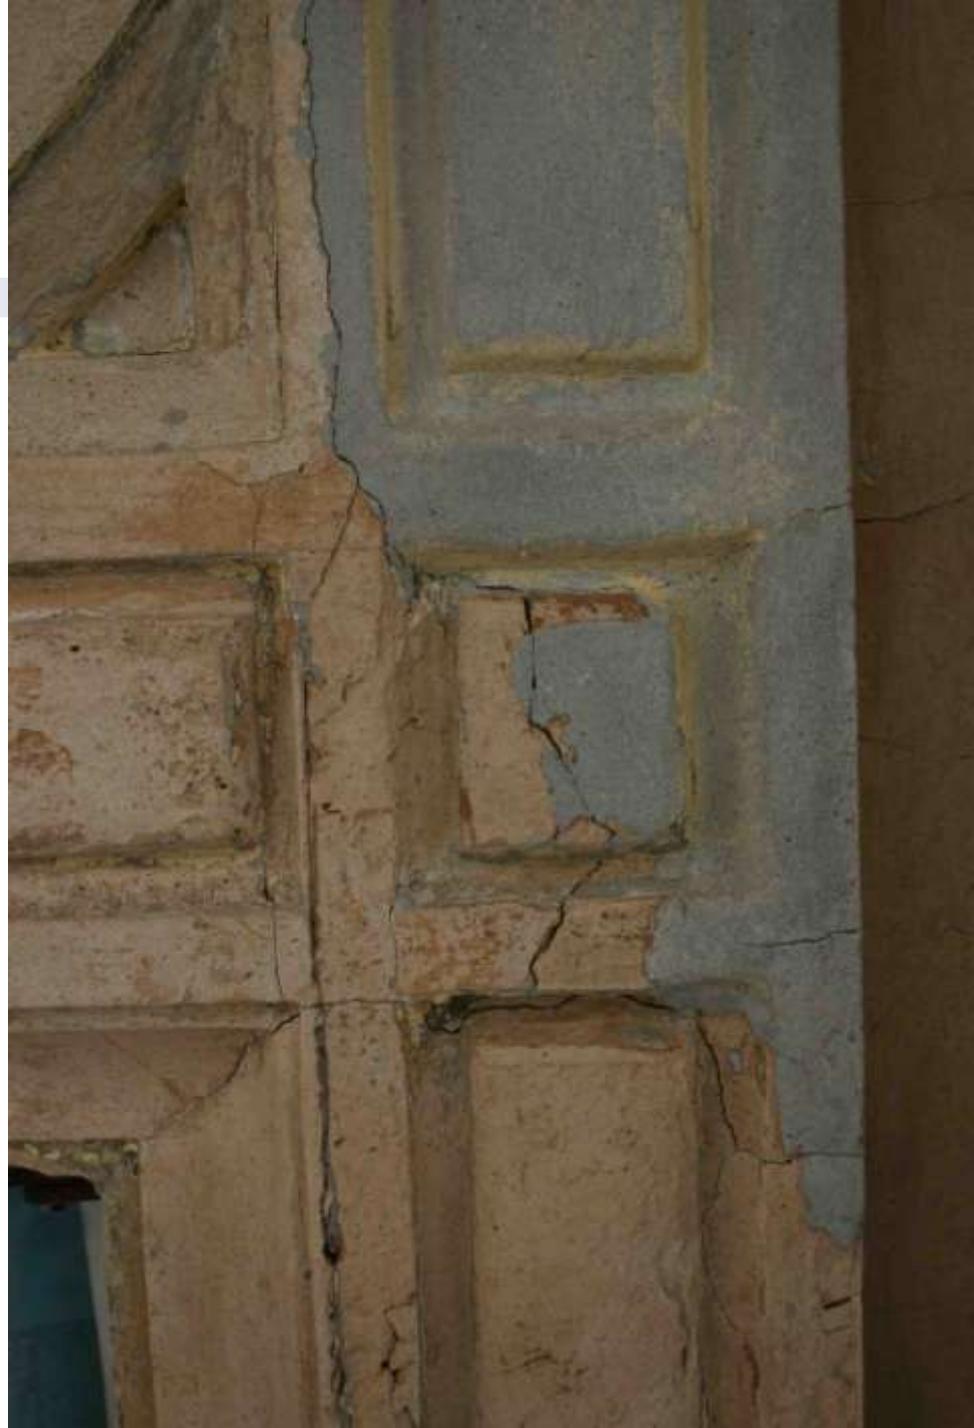
repairs with
incompatible
Portland cement
mortars

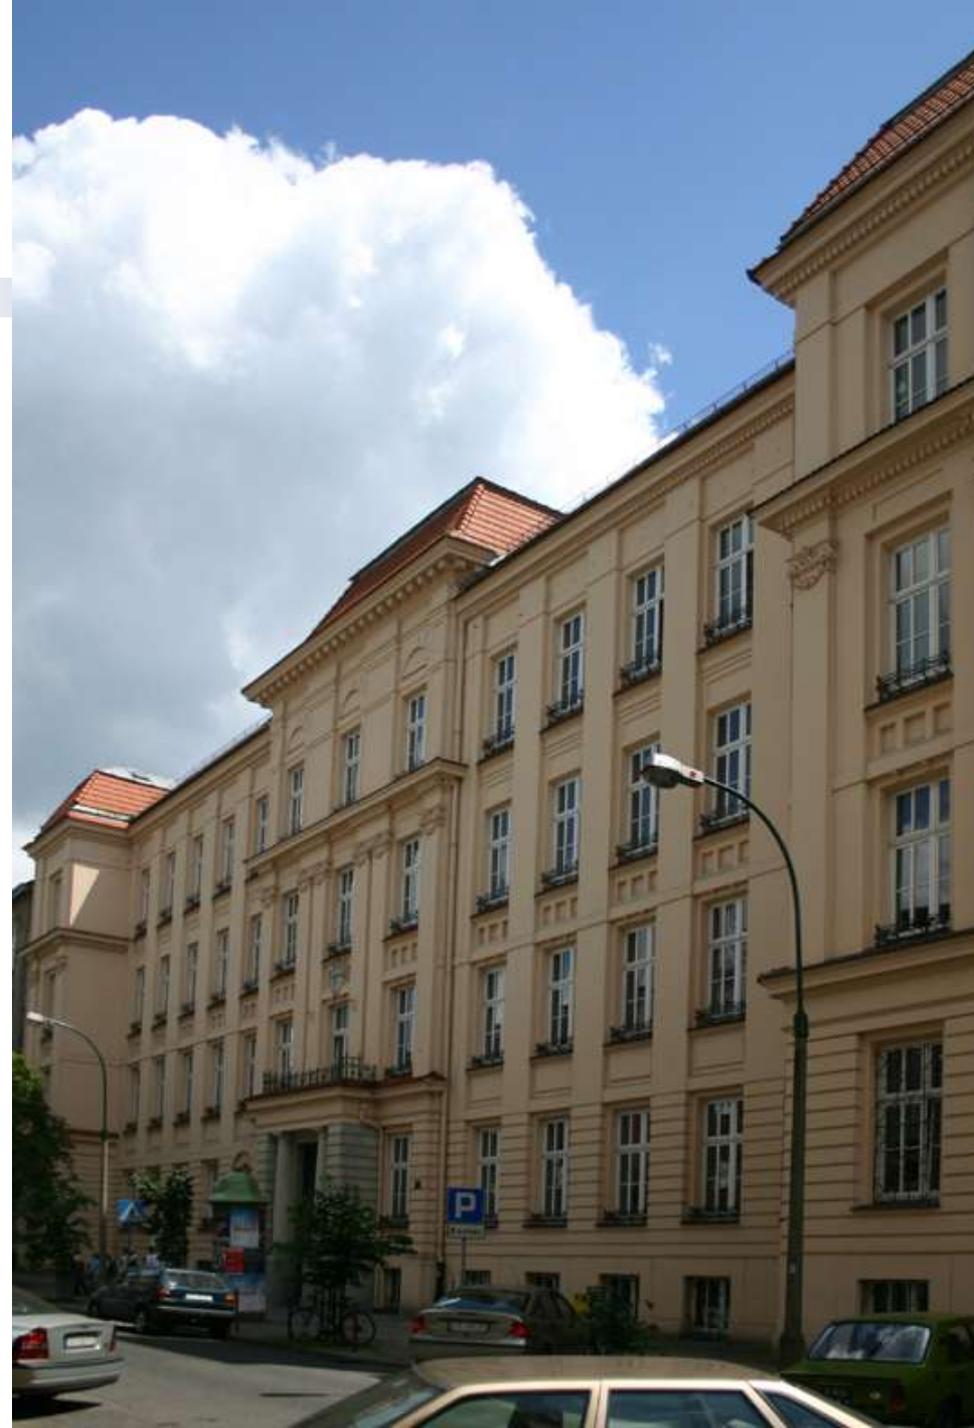
Municipal school, 1908-1911

irreversible coating with
modern paint

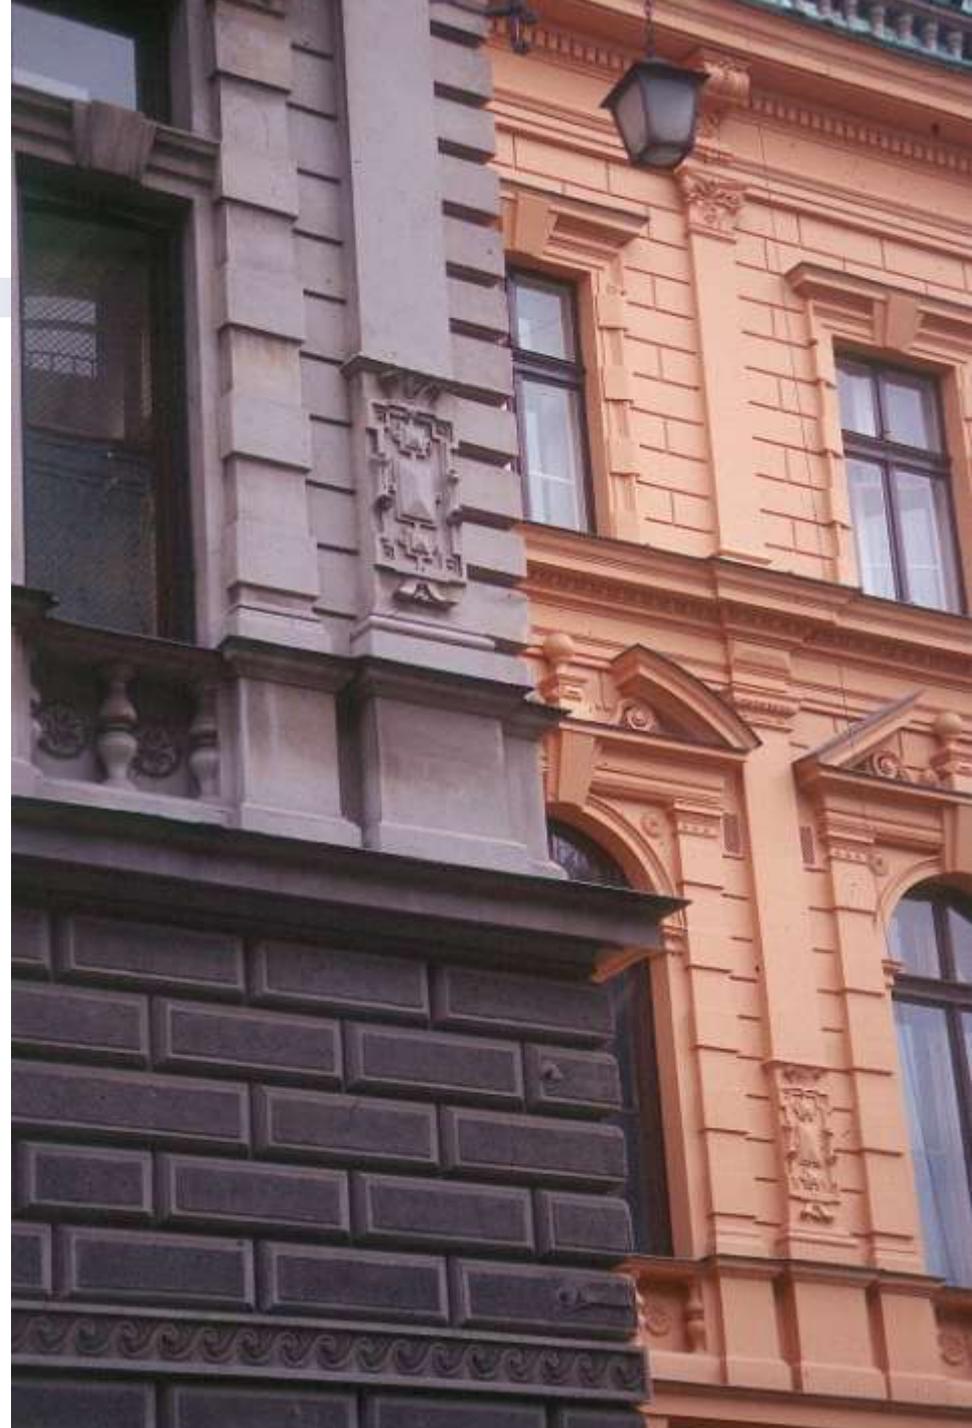
Communal Savings Bank, 1881-1883

a facade repainted
in a colour resembling
the original appearance

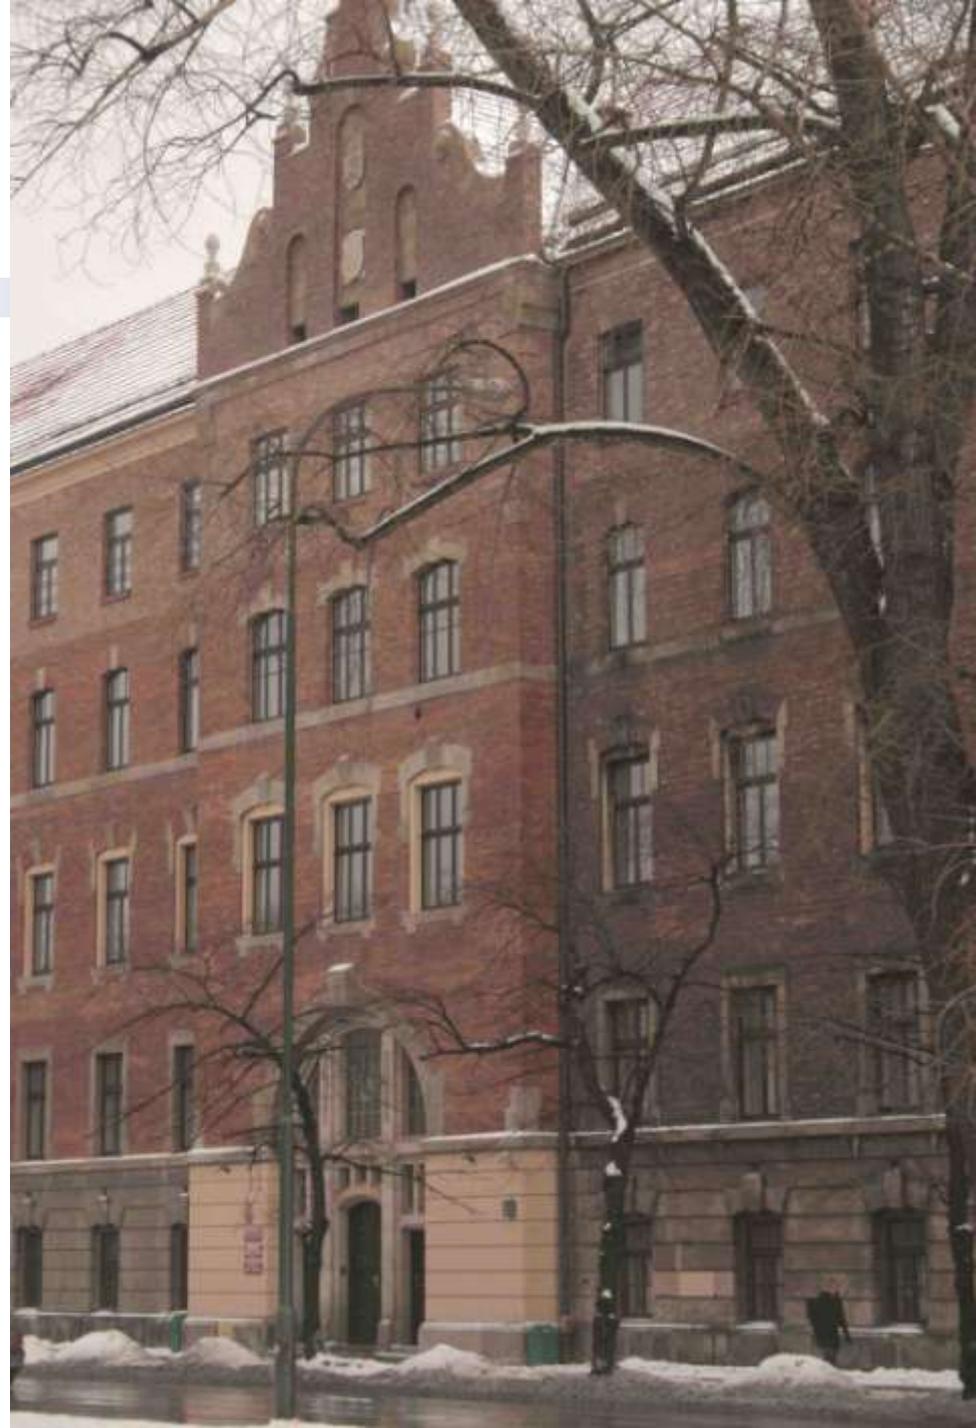
Agricultural College

painting over is selected
even if Roman cement
renders cover a fraction
of the facade and give
a good aesthetic effect
with patinated brick

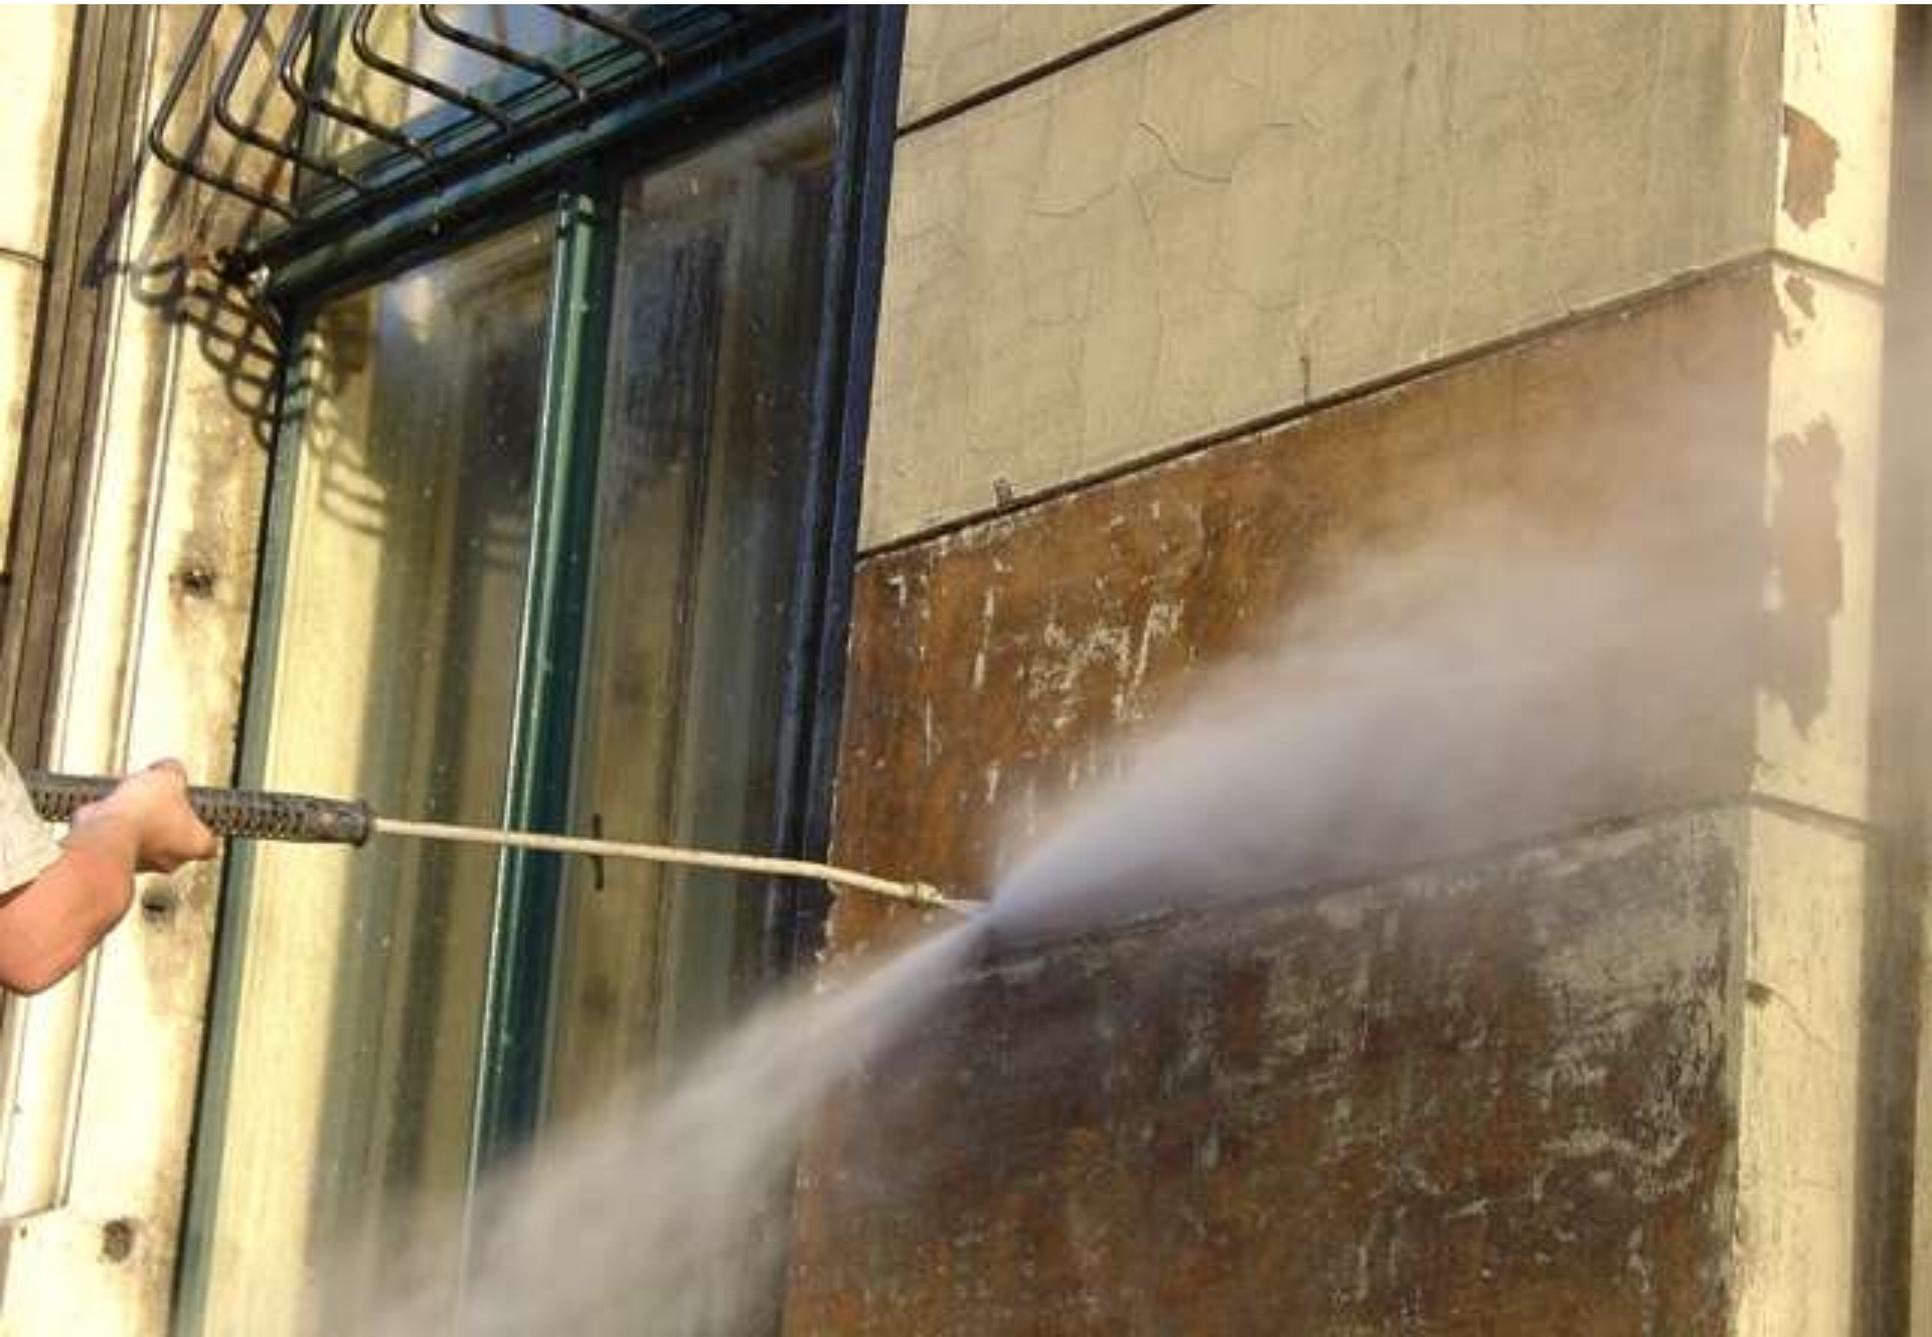
Cleaning with superheated water and sandblasting

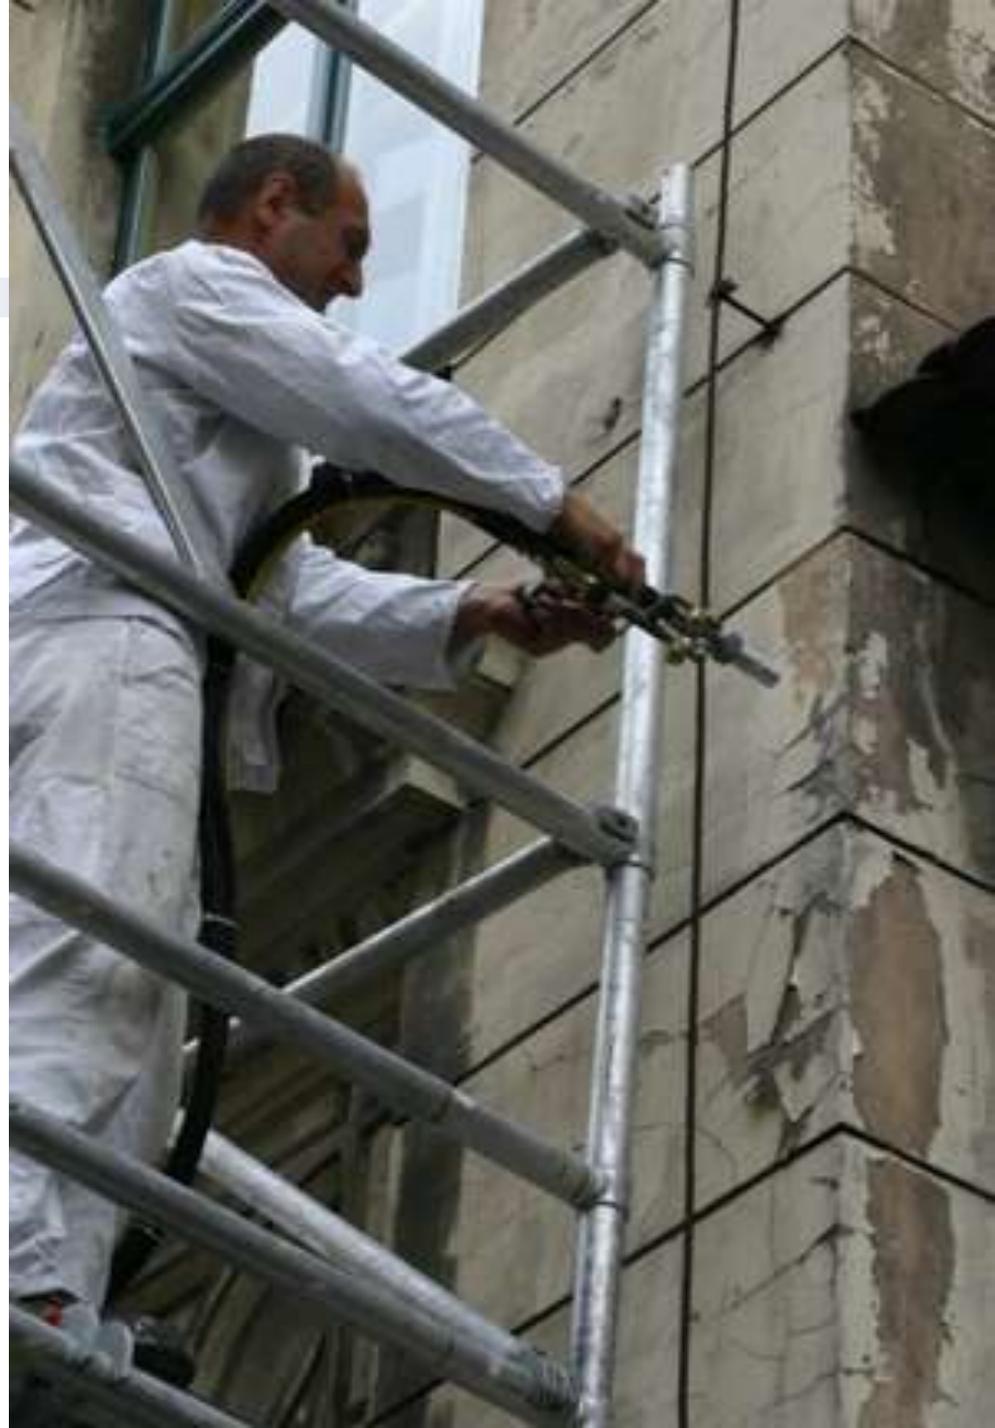
Cleaning with sandblasting

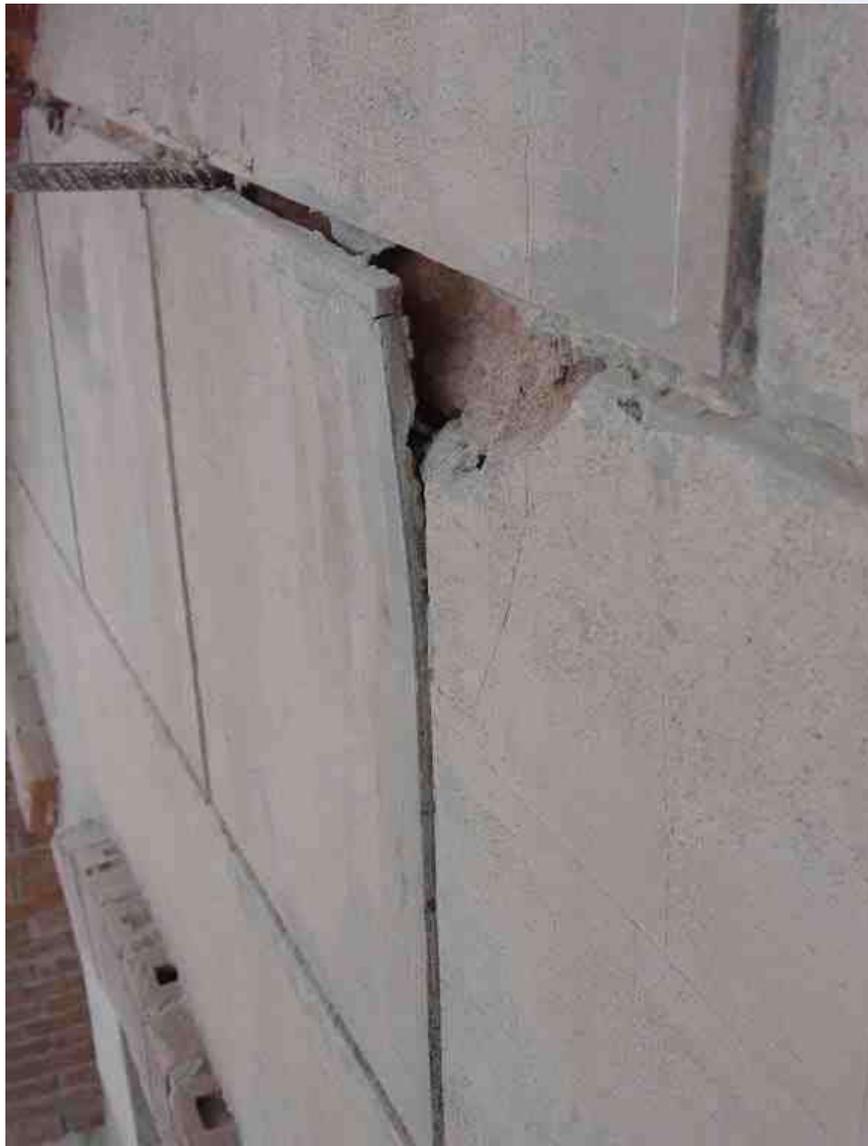
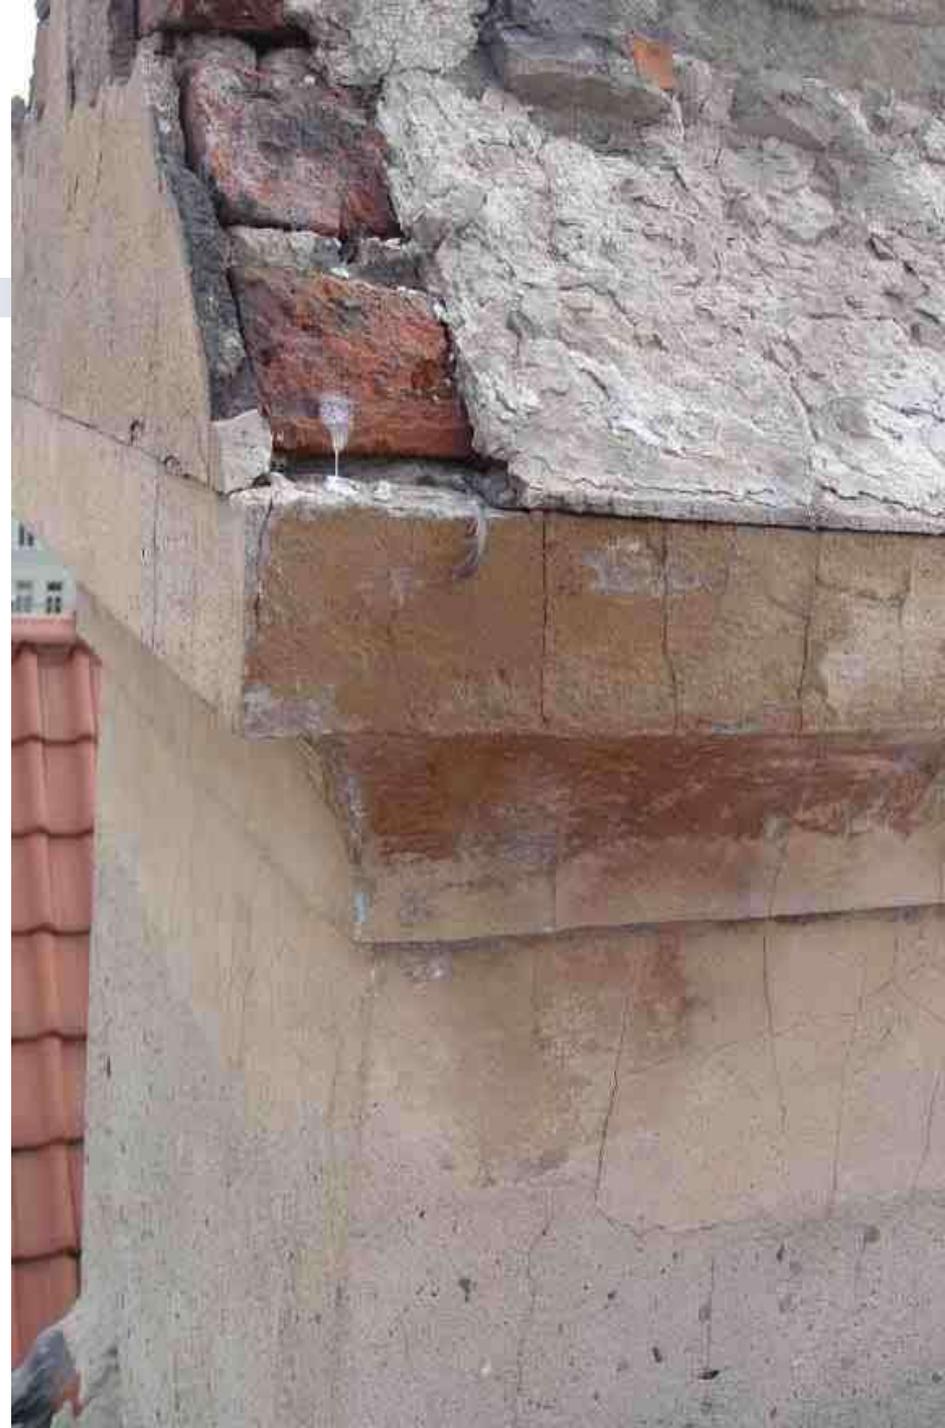
Very limited damage
of Roman cement renders

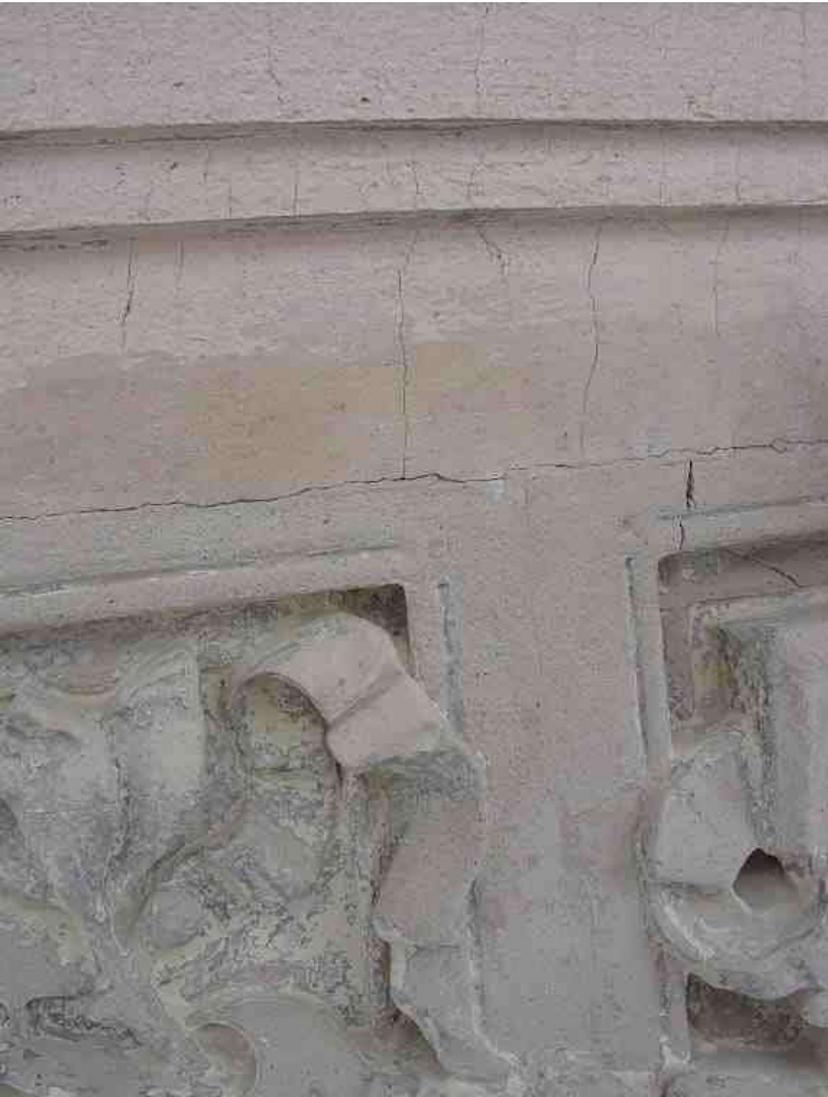
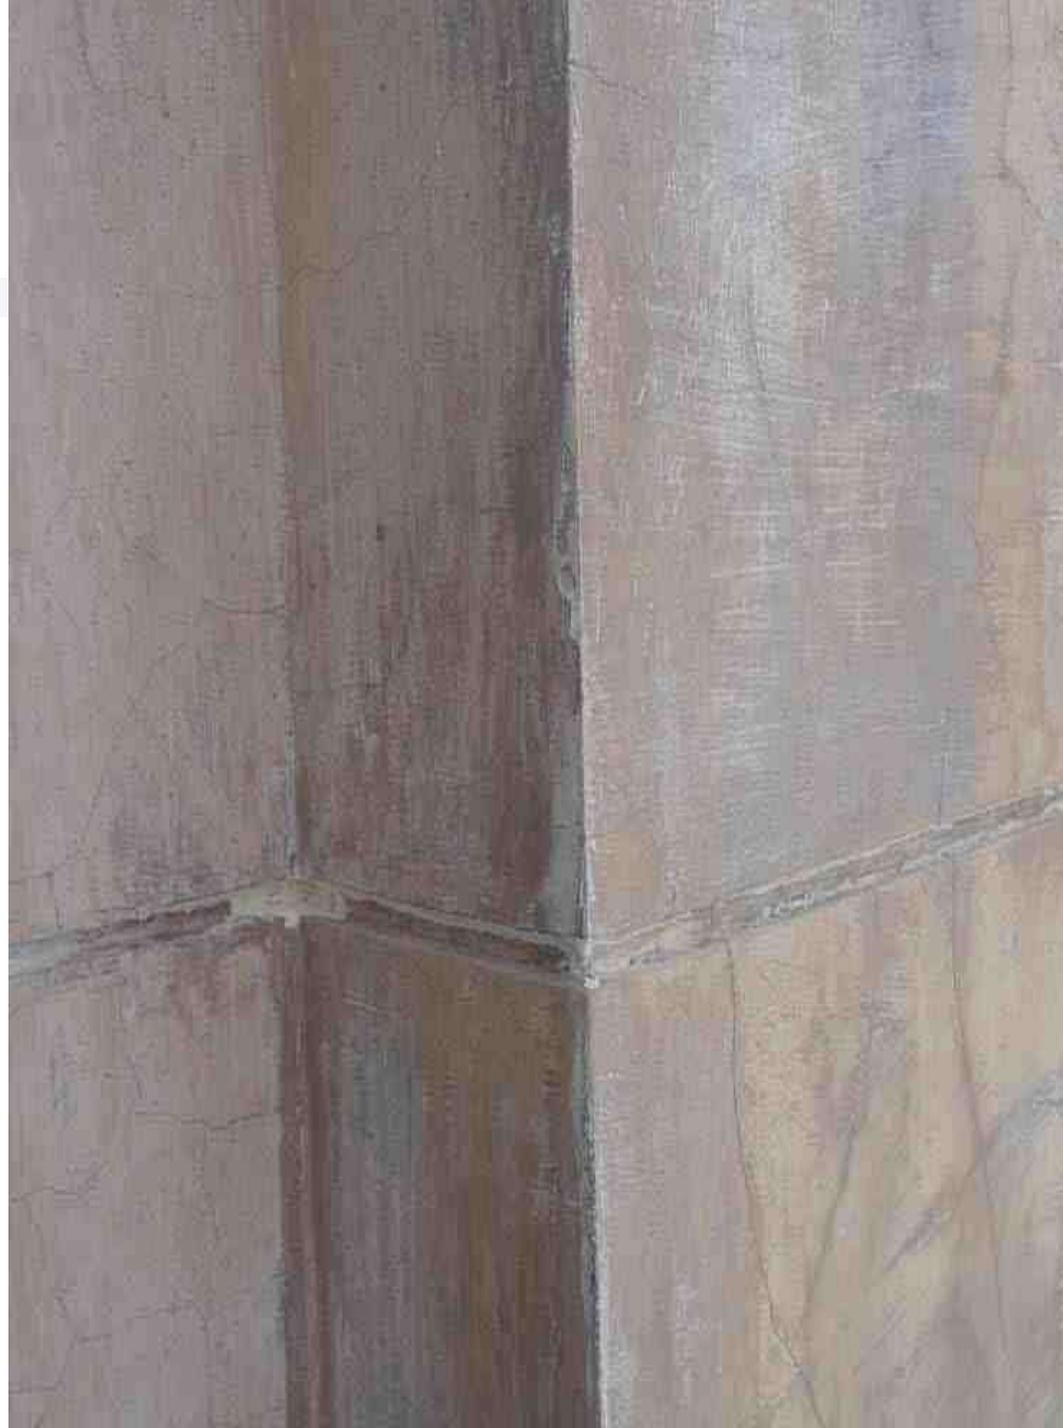
Cracked and stained surfaces

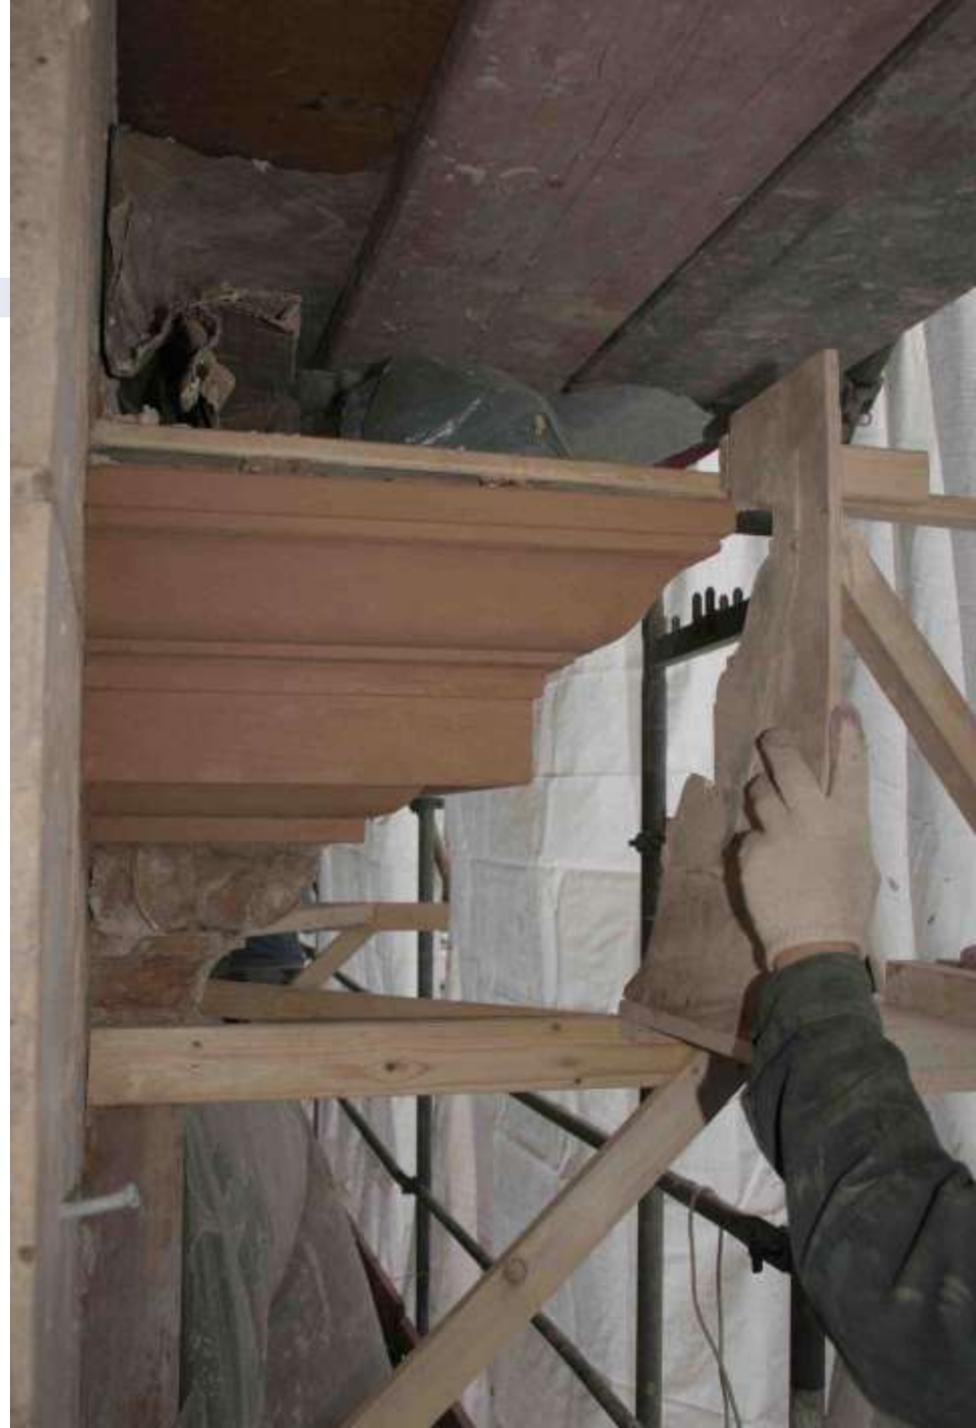
The missing part of the cornice is reconstructed using Roman cement as a binder and natural red-coloured sands (Remmers Funcosil Farbsand) as an aggregate

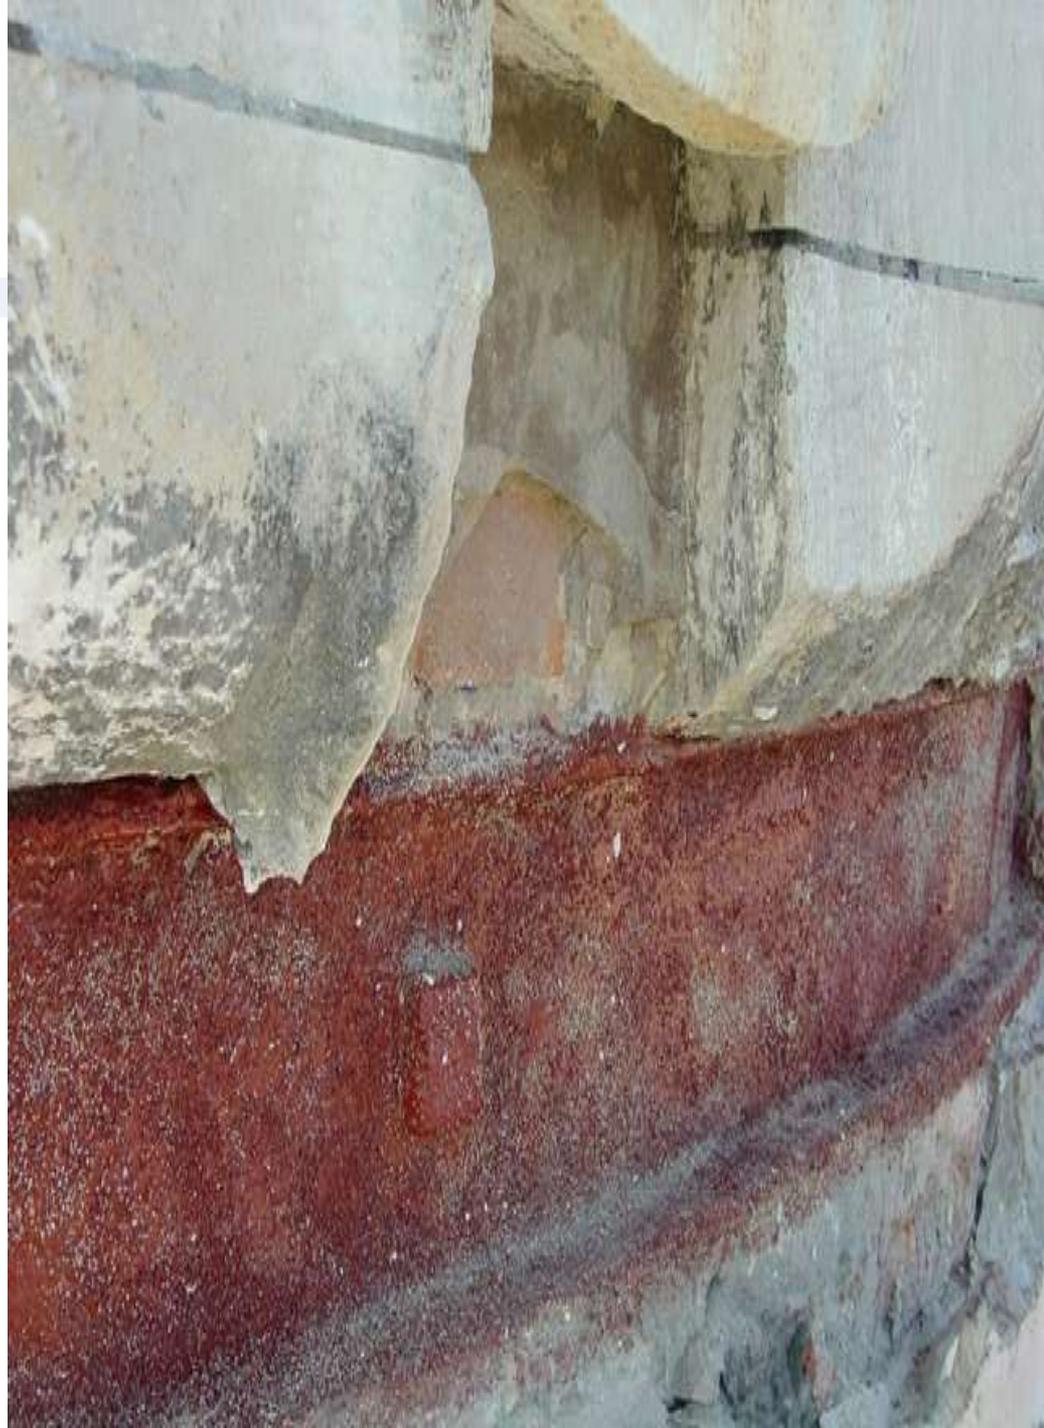
Rusted iron armature, hooks and nails were sandblasted and protected against corrosion with Remmers Epoxi Rostschutz

The fresh layer of the coating was sprinkled with sand to facilitate the adhesion of the repair

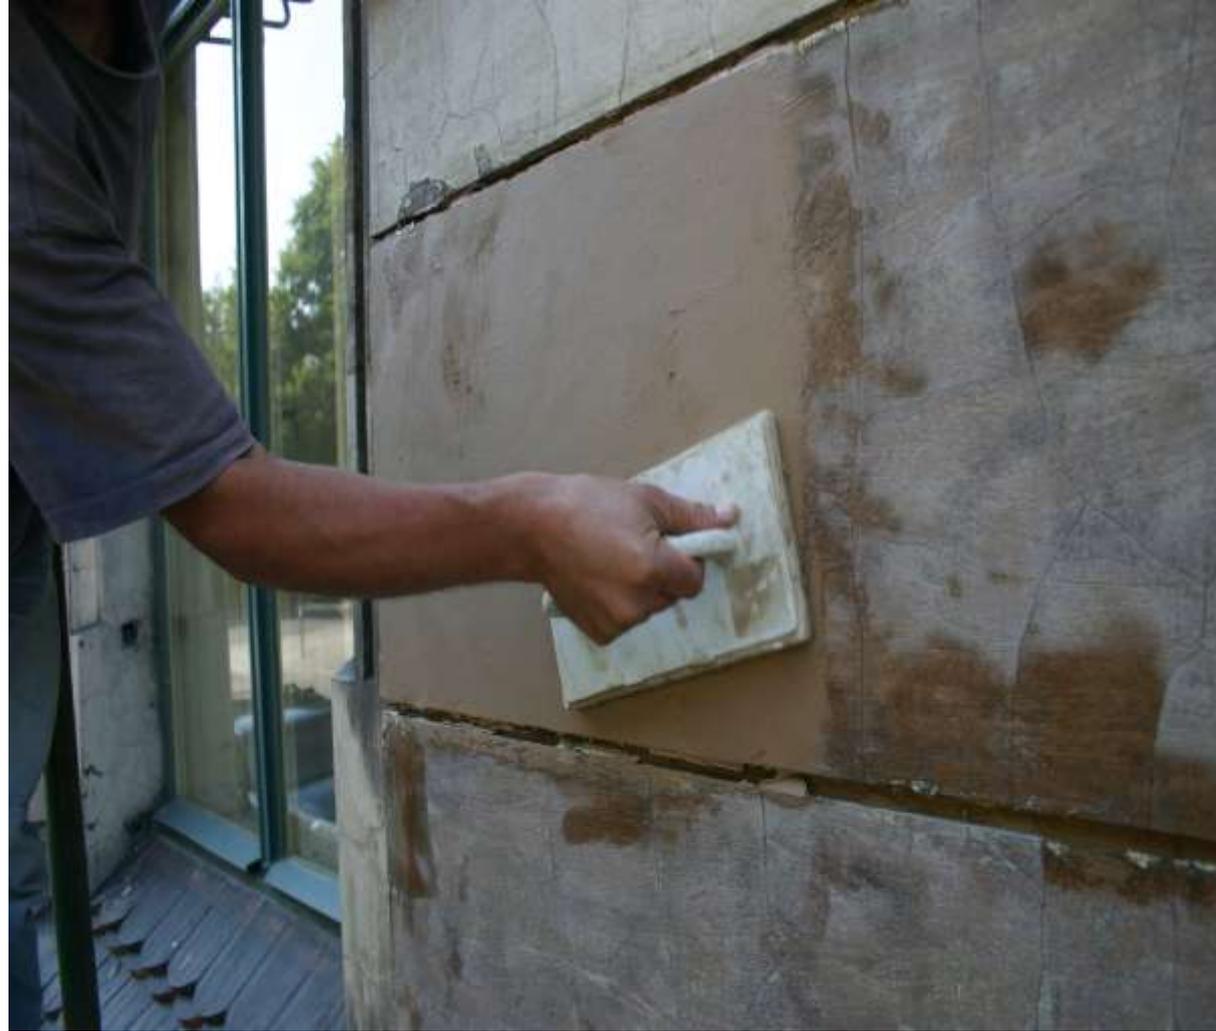
Coating of the entire architectural surface

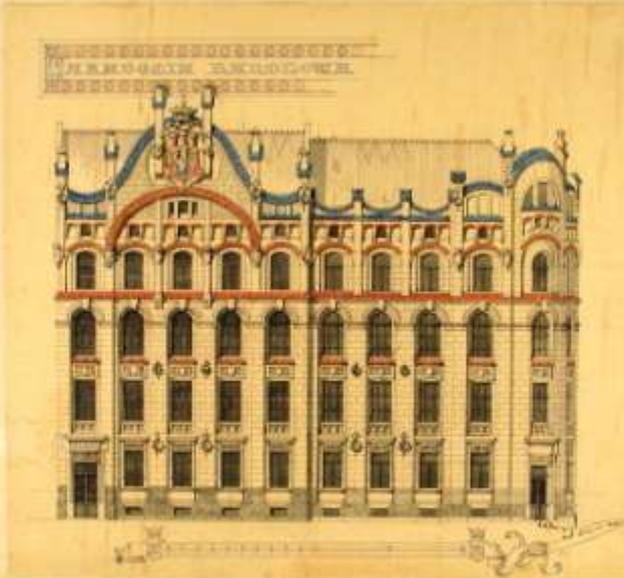
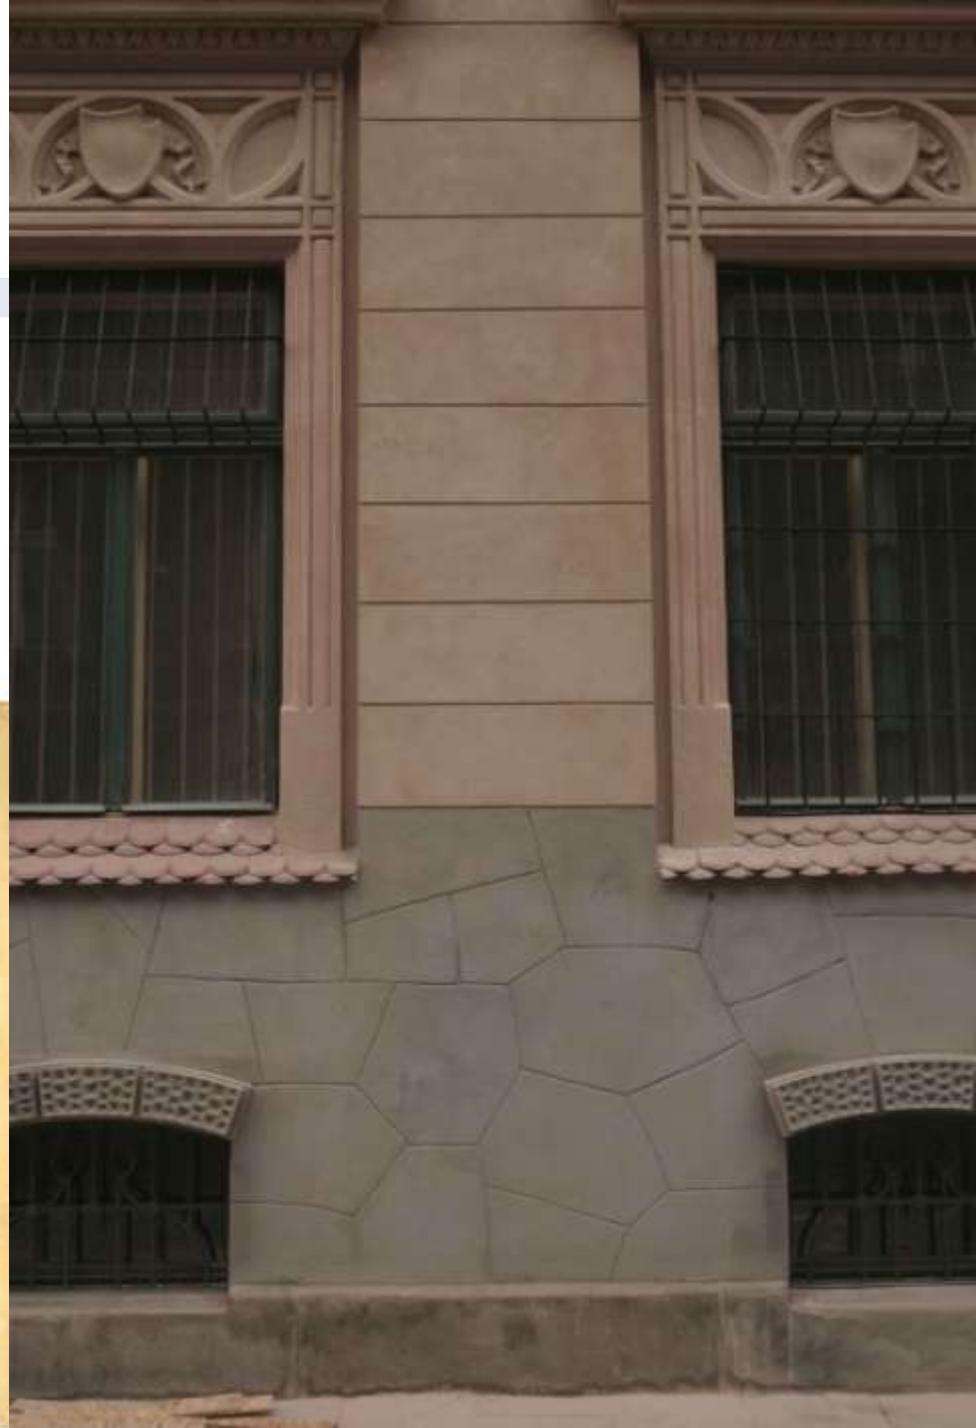
Roman and Portland cement renders were used by the architect at the base to imitate different varieties of stone
