Pilot project

-Early cement rendered buildings

Activity 1: Write a short history of the development at Oscarshall Palace and examine a few other buildings in Oslo, to evaluate the usage of cement in Oslo between 1840-1880.

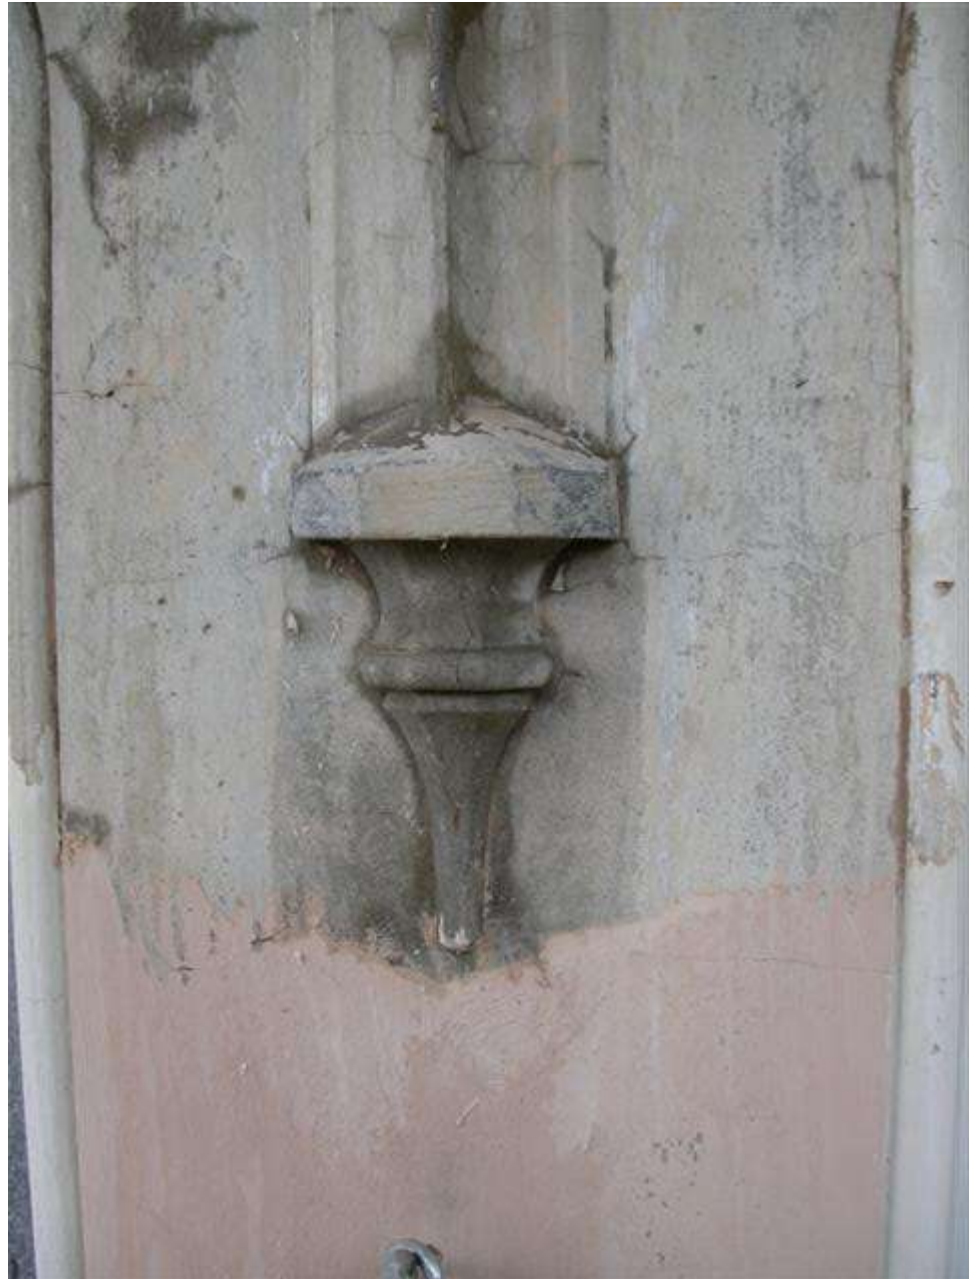
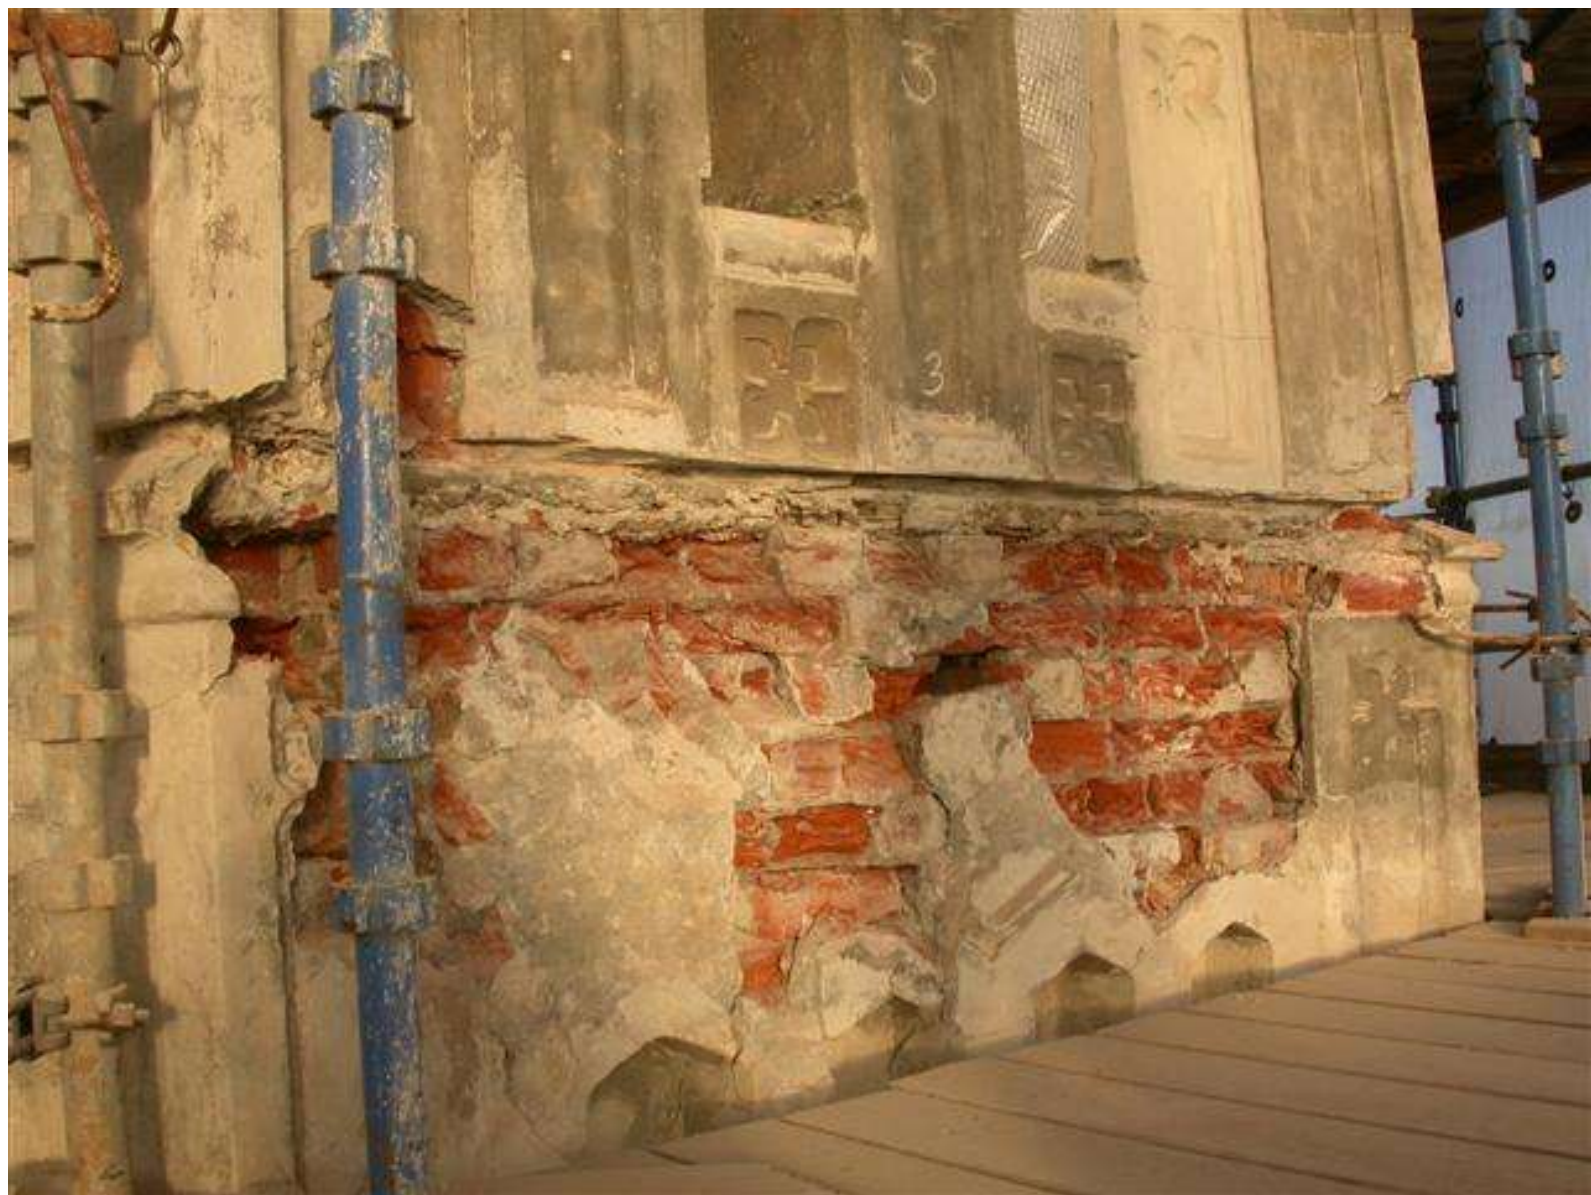
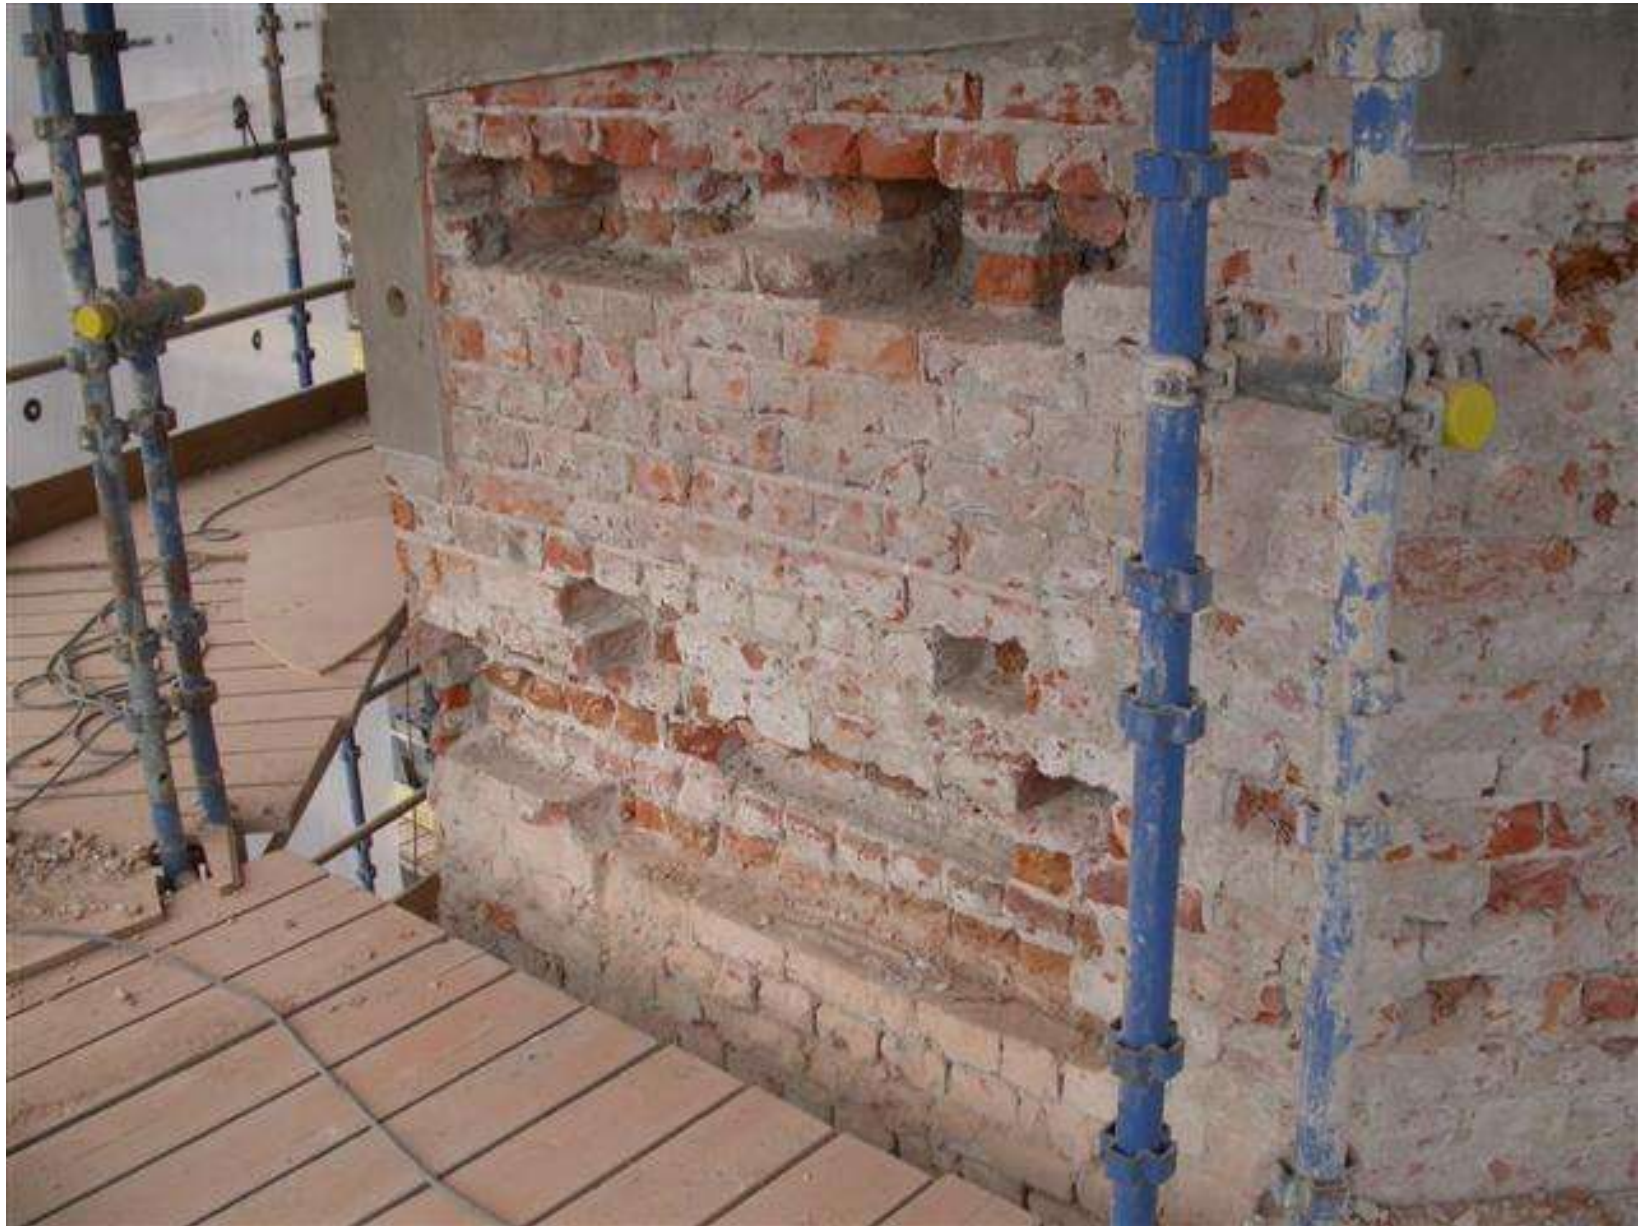
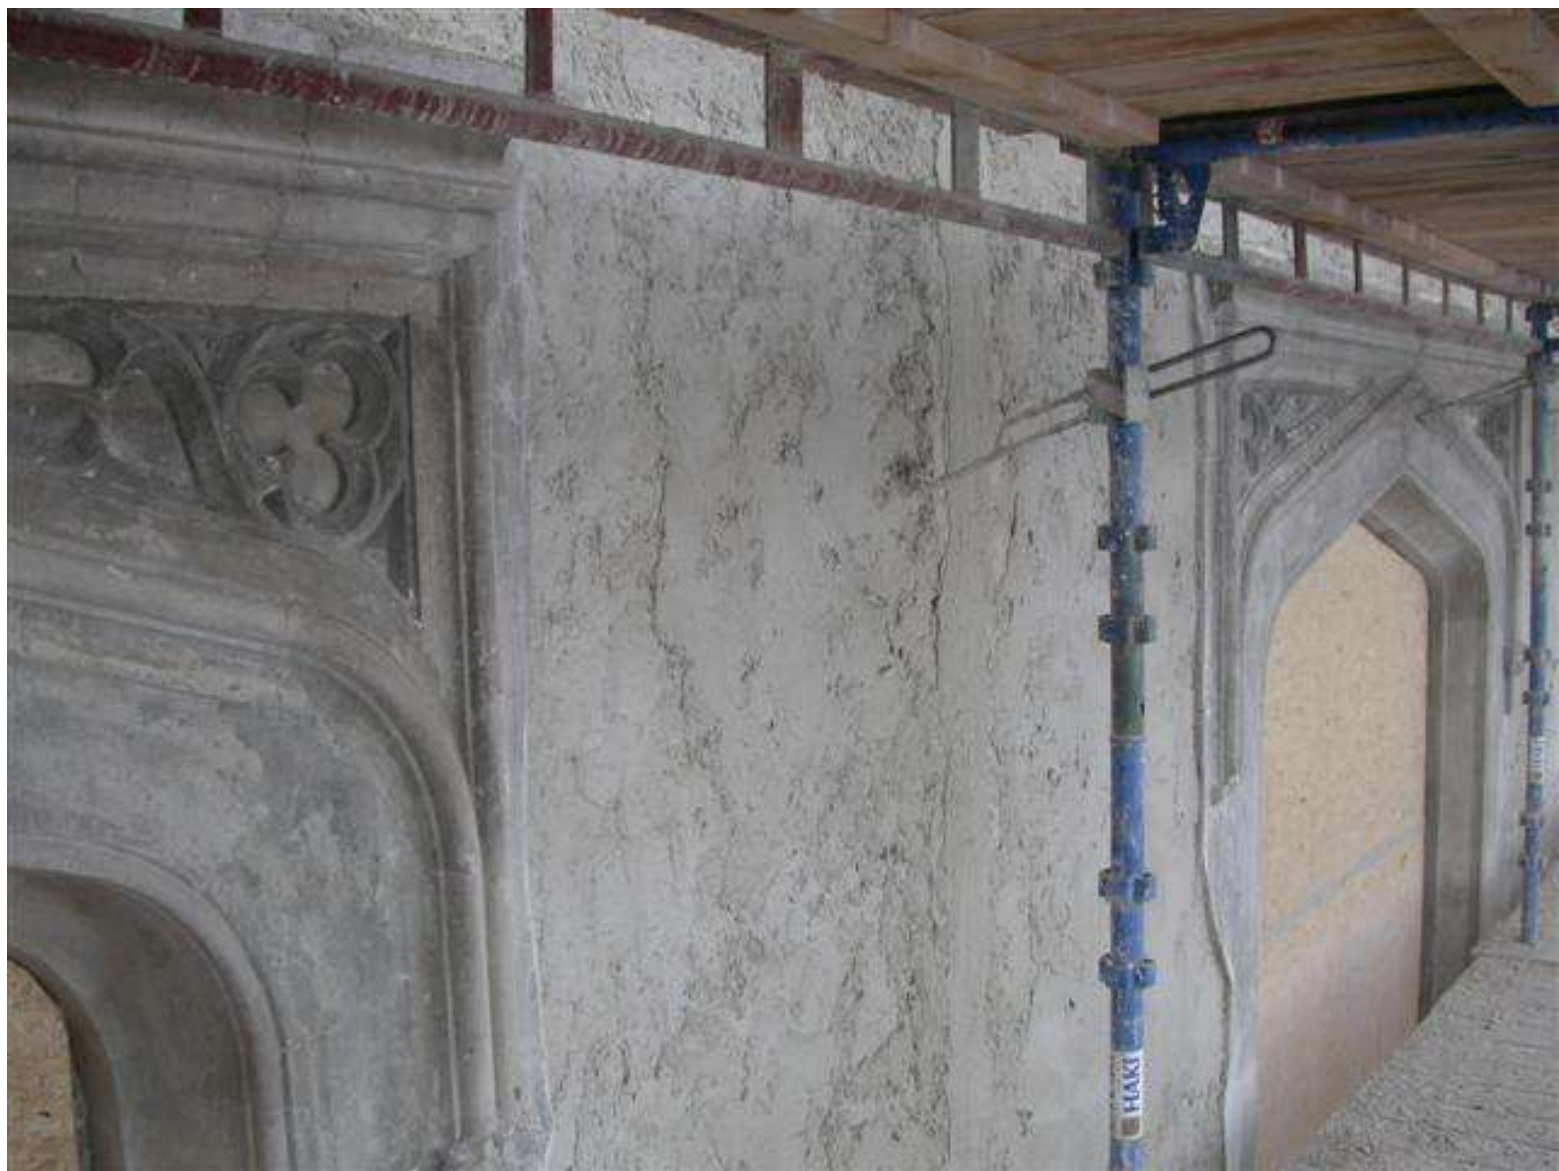
We tried removing the paint in May 2007 with four different methods:

1. Only the chemical STS 7M followed by hot water.
2. Chemical removers followed by JOS-blasting with calcite and water.
3. Chemical removers followed by TORBO-blasting with quartz (7 bar)
4. Only TORBO blastering with quartz (7 bar).
